2x Caterpillar G3520H Engine Condition Report

The engine order was cancelled due to improper covering during the original transport. Some water may have got into the cooling circuit. Our inspection shows that the main components of the engine: in the bottom end, in the cylinders and the turbo condition is as new.

Make & Model: Caterpillar G3520H

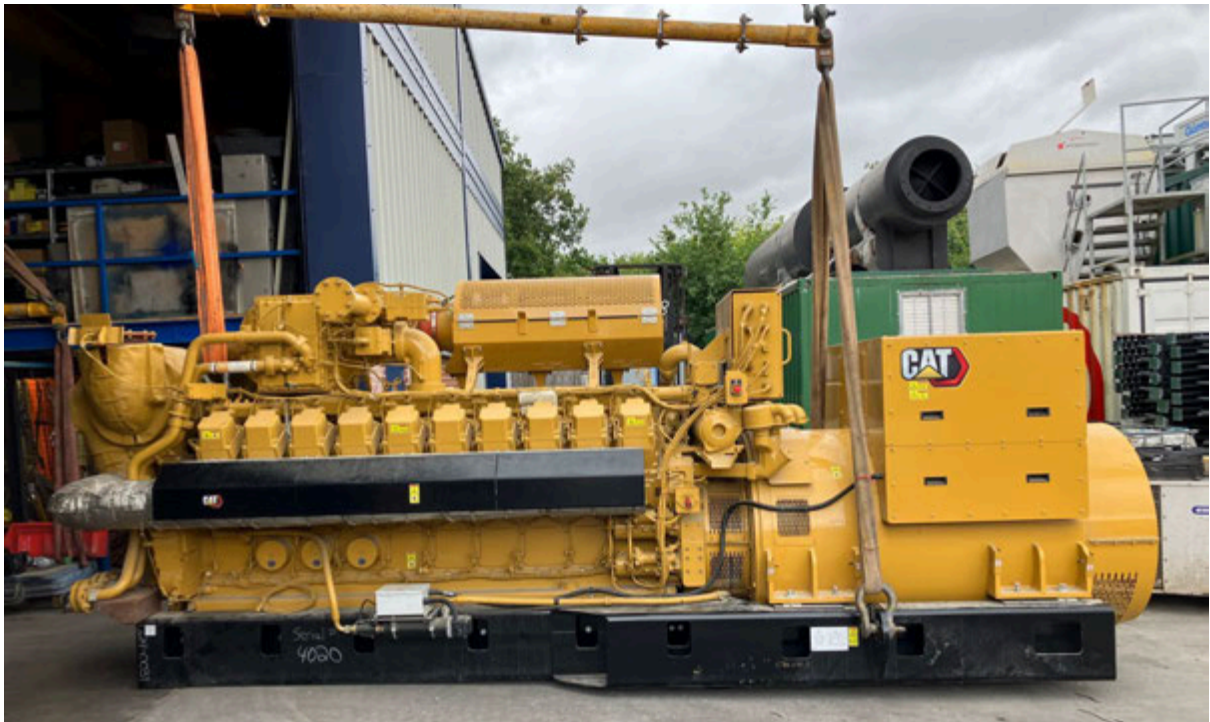
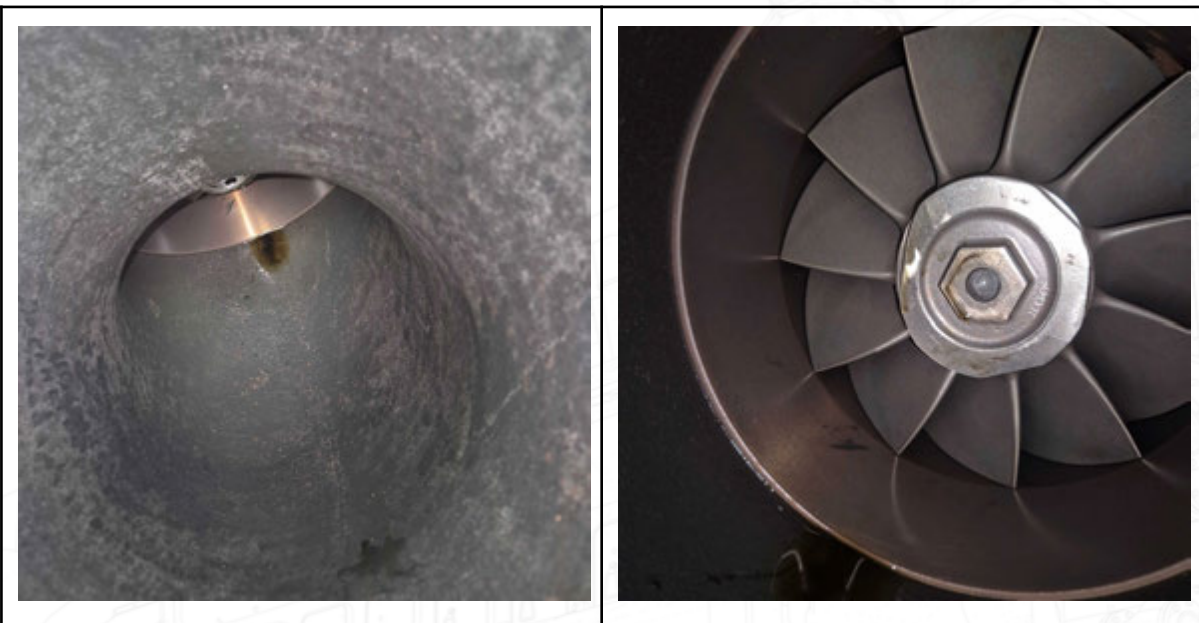
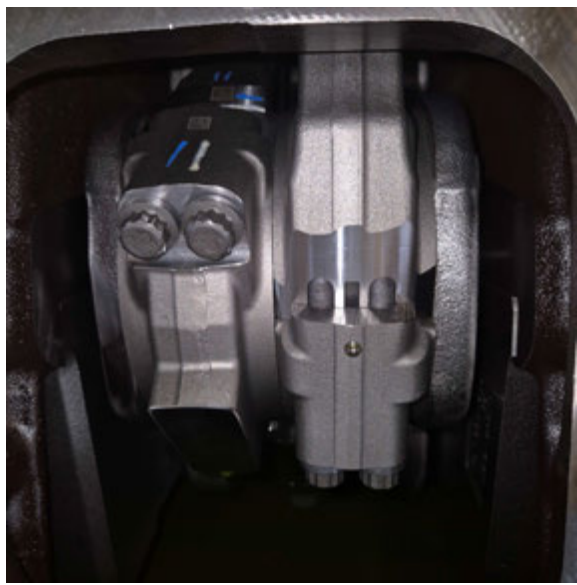
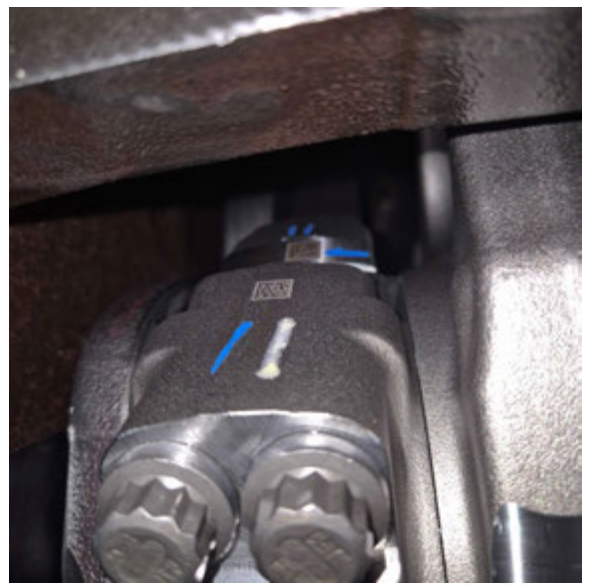
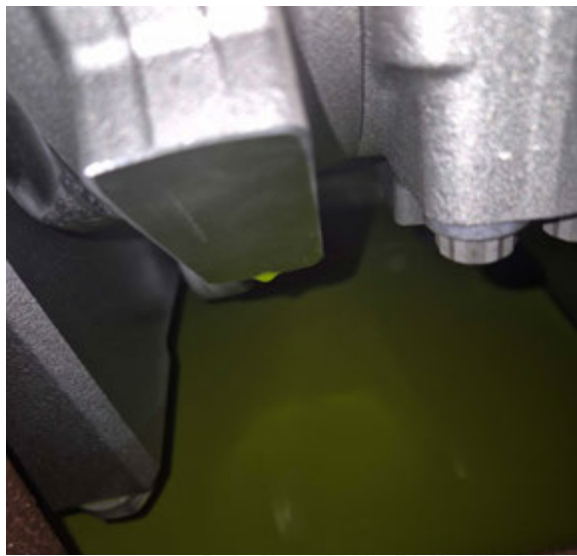
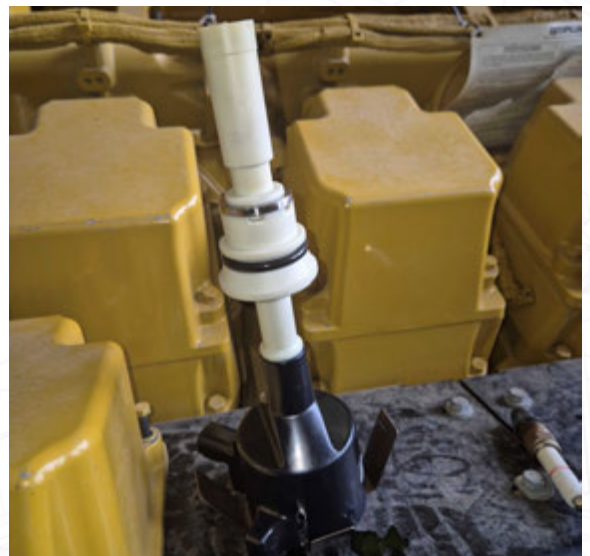
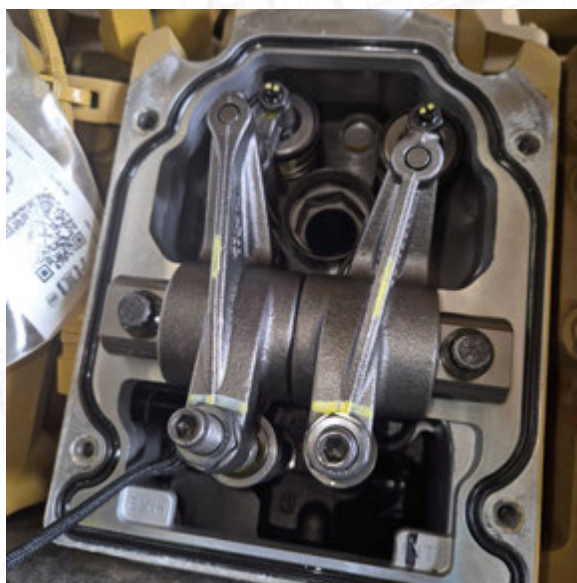
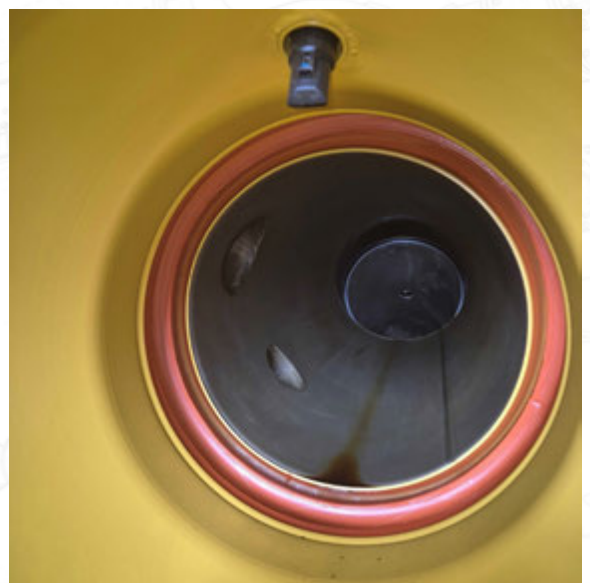
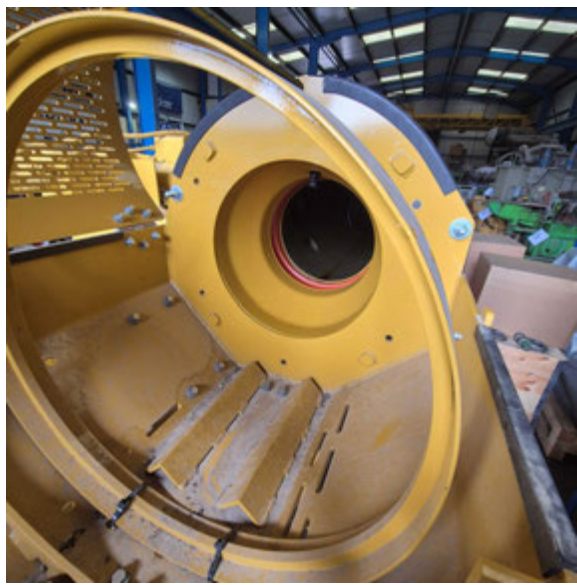
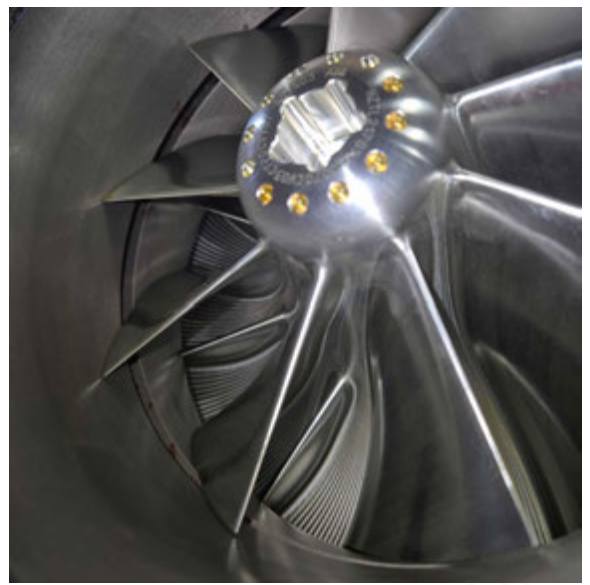
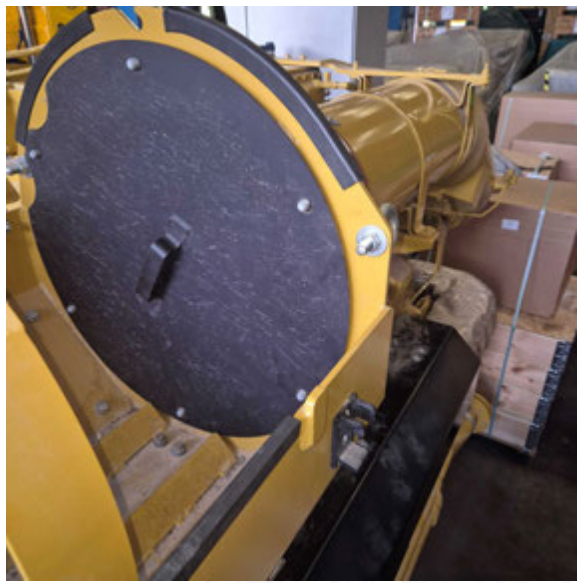
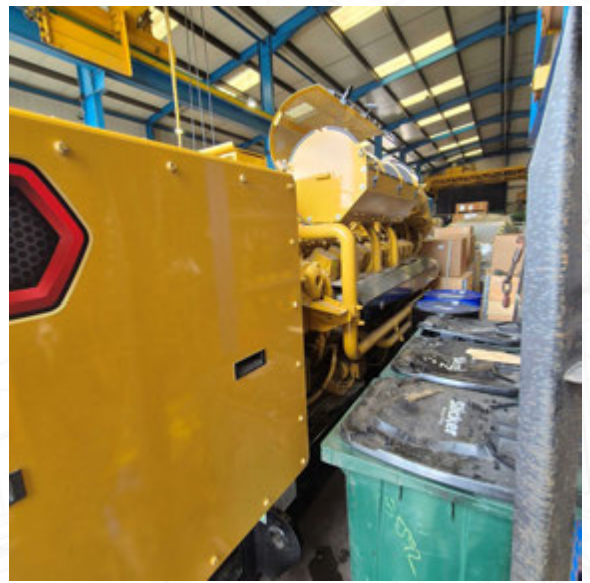
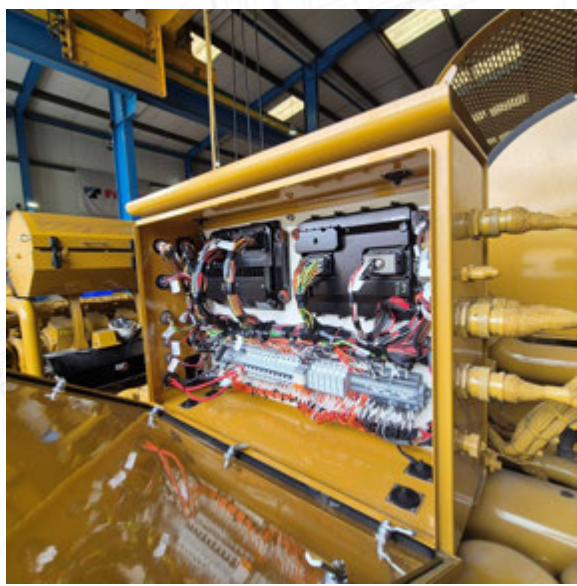
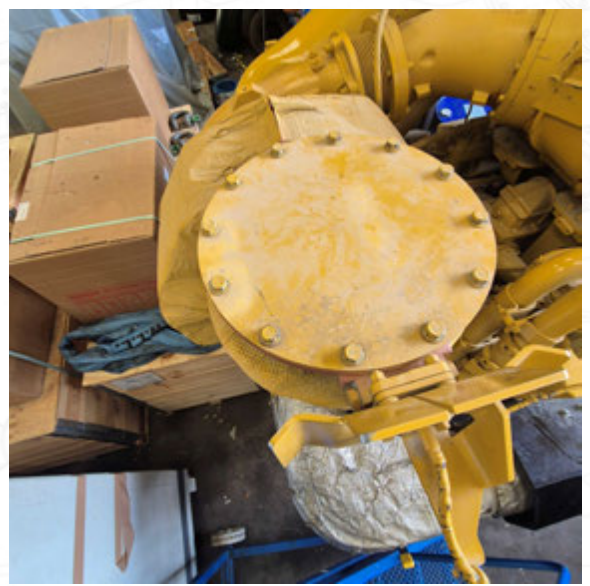
ENGINE 1

Turbo: Both air side and exhaust side inspected and photographed, found to be in as new condition. No ingress of foreign matters.

Cylinders: Removed rocker covers, coils/HT leads and spark plugs. Inspected cylinders with borescope, found to be in as new condition. No ingress of foreign matter.

Cylinders 2 & 11 had no coil fitted, cylinder 9 had neither coil or spark plug fitted.

Crankcase doors removed to inspect crank and connecting rods, all found to be in as new condition. No ingress of foreign matter.

The air filter was not fitted but the air inlet chamber was sealed to the elements as was the turbo exhaust.

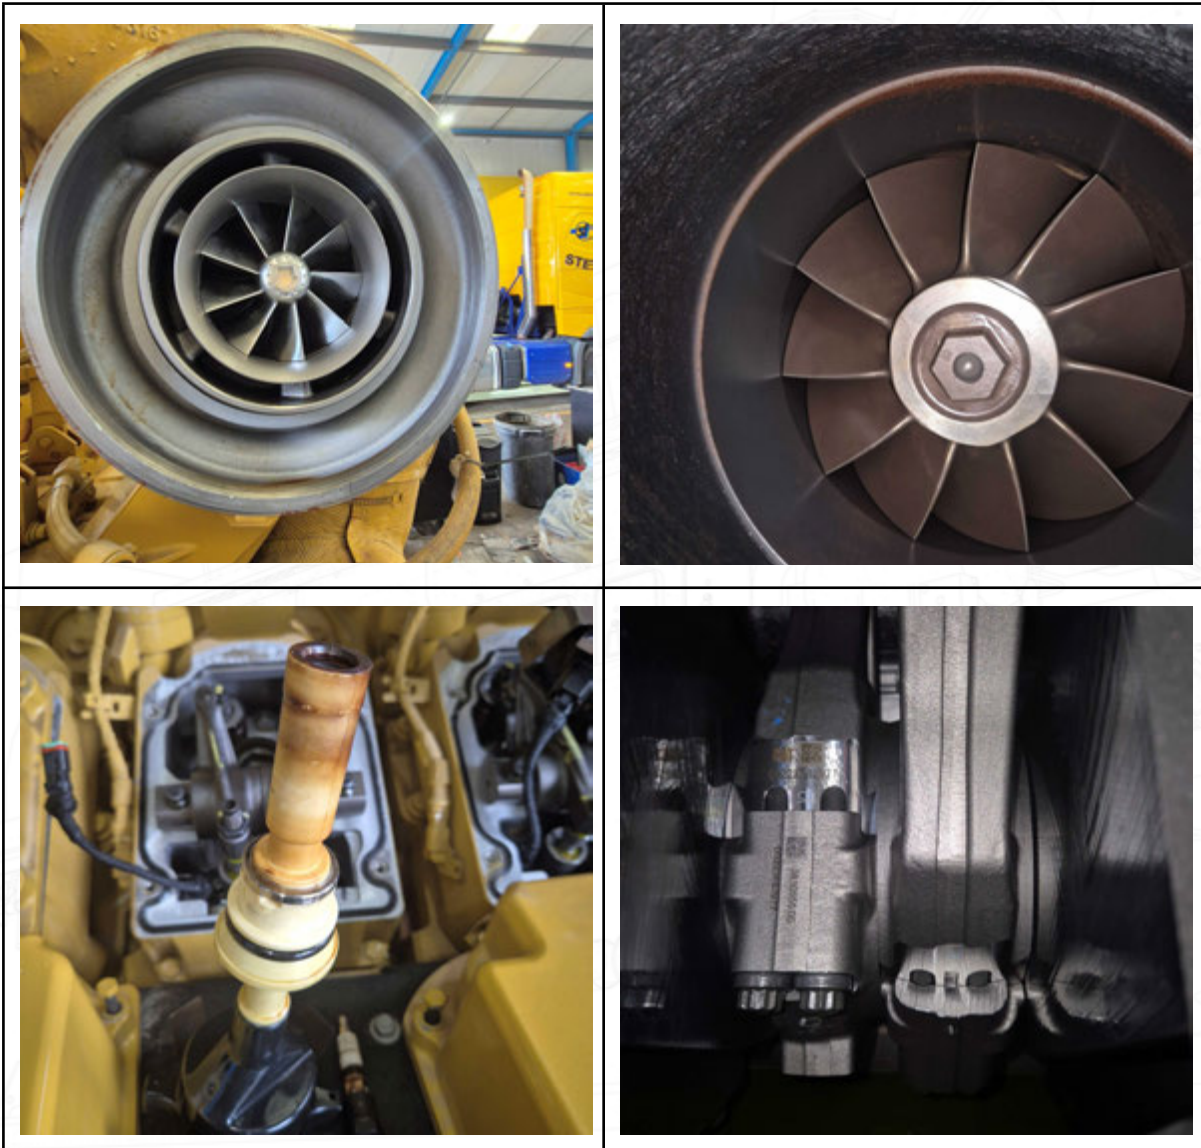
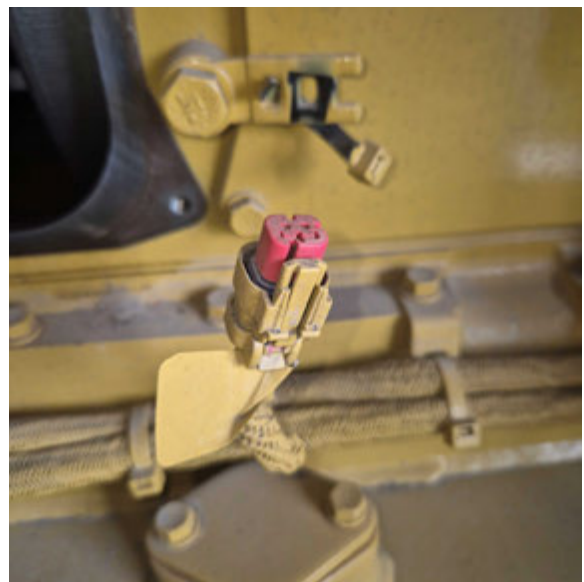
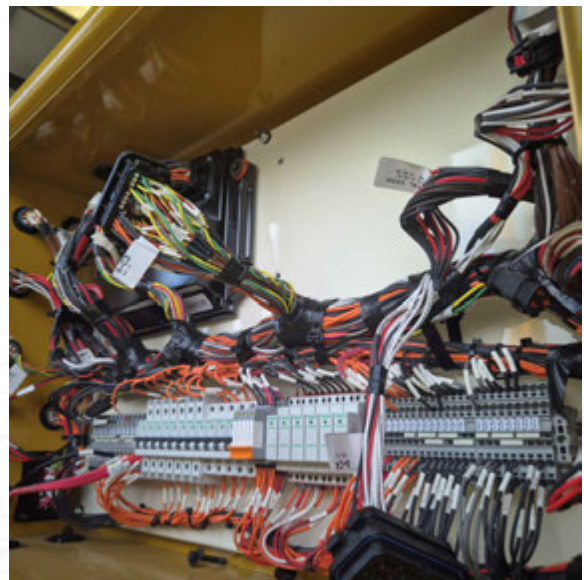
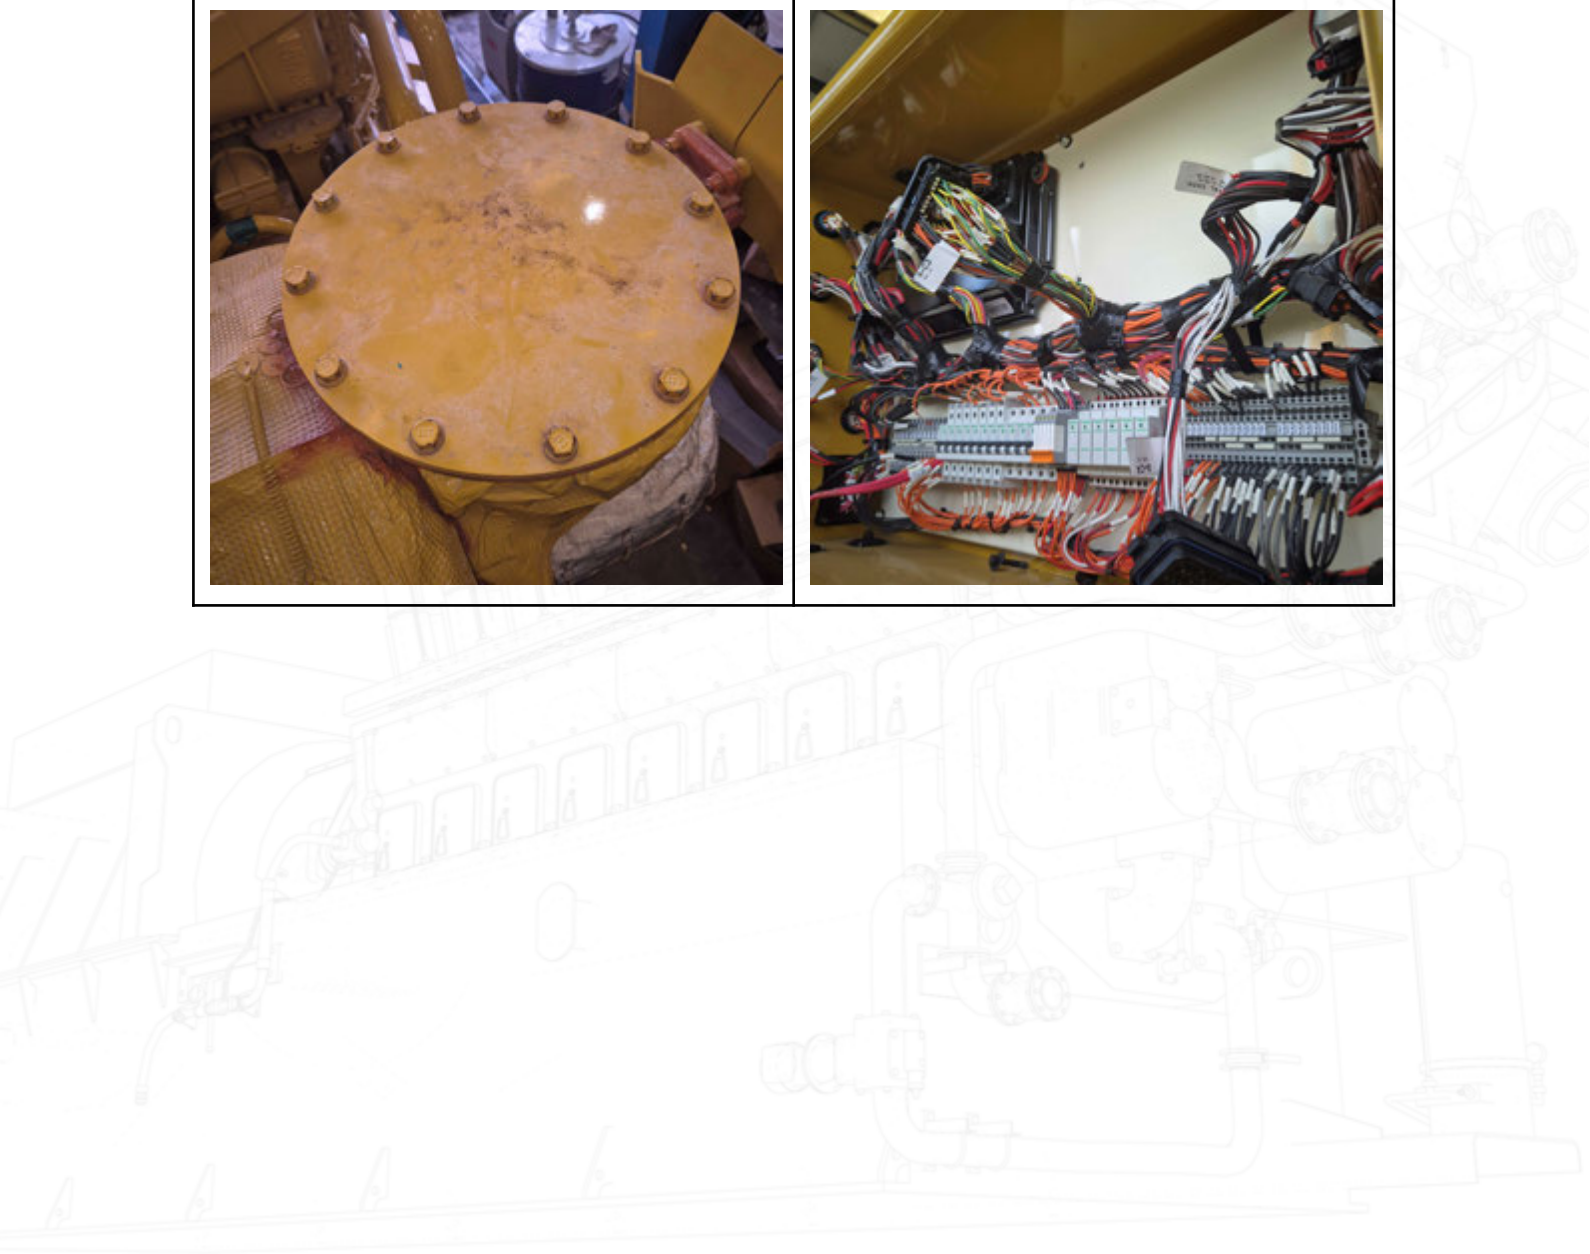
ENGINE 2

Turbo: Both air side and exhaust side inspected and photographed, found to be in as new condition. No ingress of foreign matters.

Cylinders 2, 6 & 13 had new coils but used spark plugs. All remaining cylinders had used coils and used spark plugs.

Crankcase door removed to inspect crank and connecting rods, all found to be in as new condition. No ingress of foreign matter. The air filter was not fitted but the air inlet chamber was sealed to the elements as was the turbo exhaust.

Cylinder 16, T/C missing.

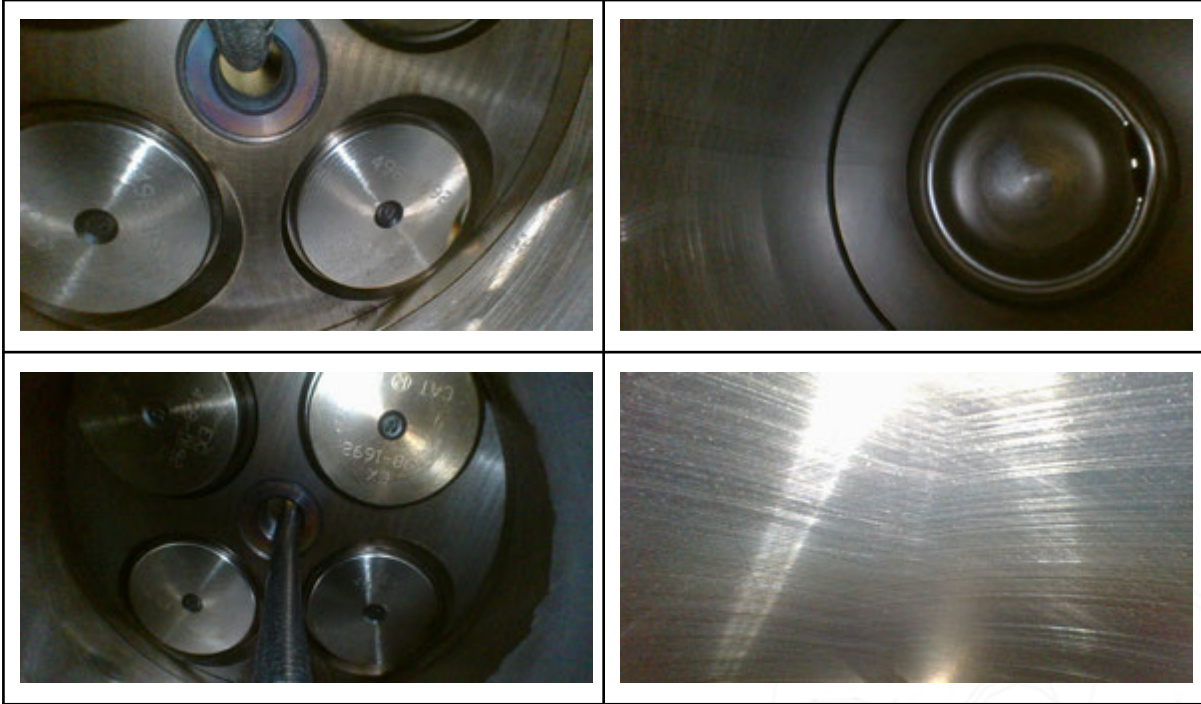
ENGINE 2 BORESCOPE PHOTOS

Cylinders: Removed rocker covers, coils/HT leads and spark plugs. Inspected cylinders with borescope, found to be in as new condition. No ingress of foreign matter.
