## **2x Caterpillar G3520H Engine Condition Report**

**Make & Model:** Caterpillar G3520H

**Capacity:** 2,500 kW

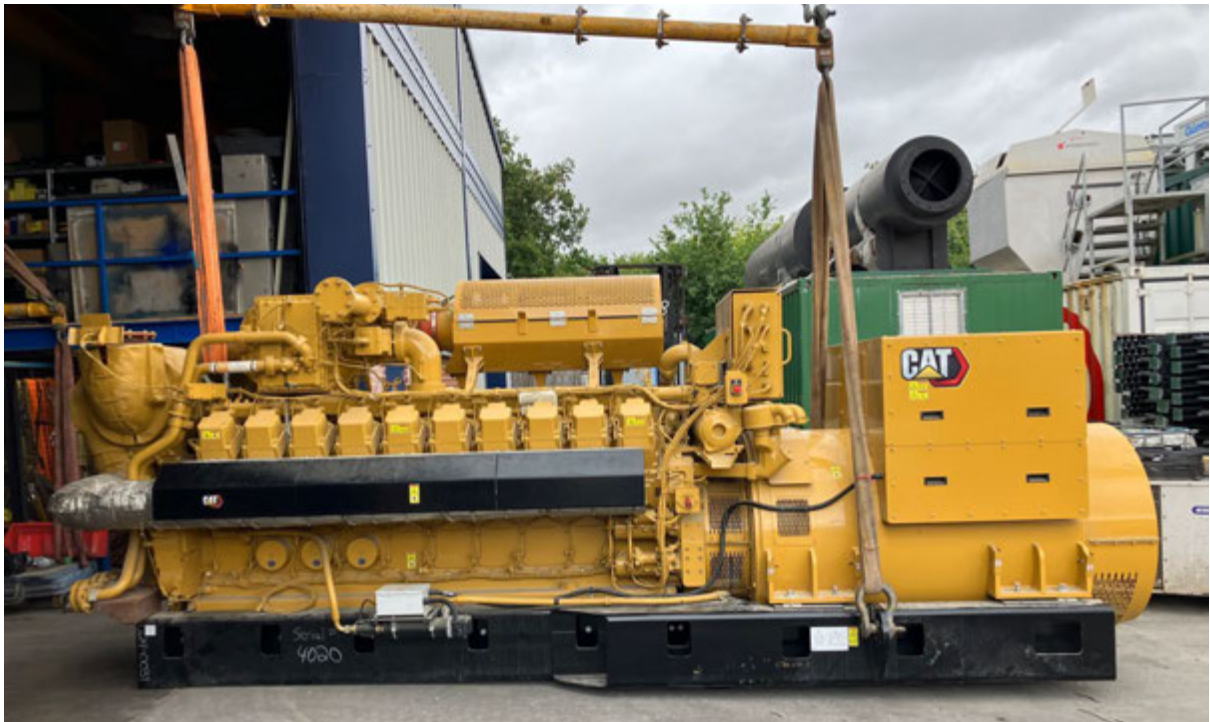
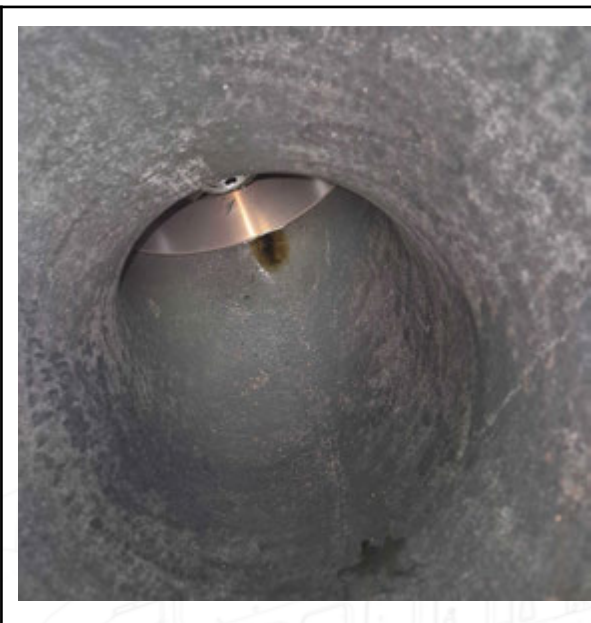
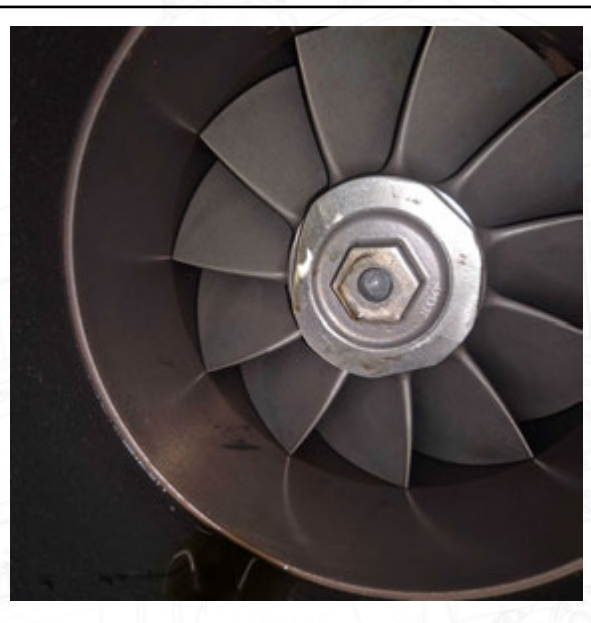
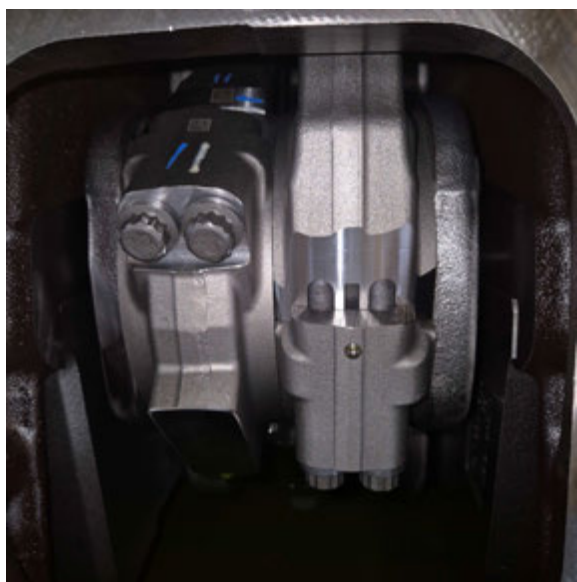
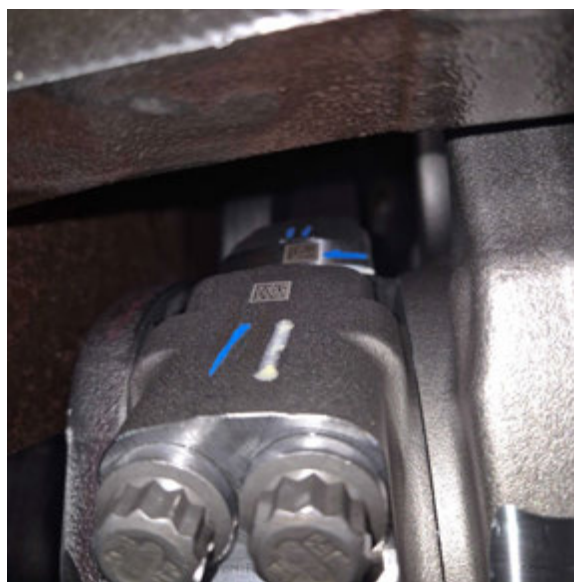
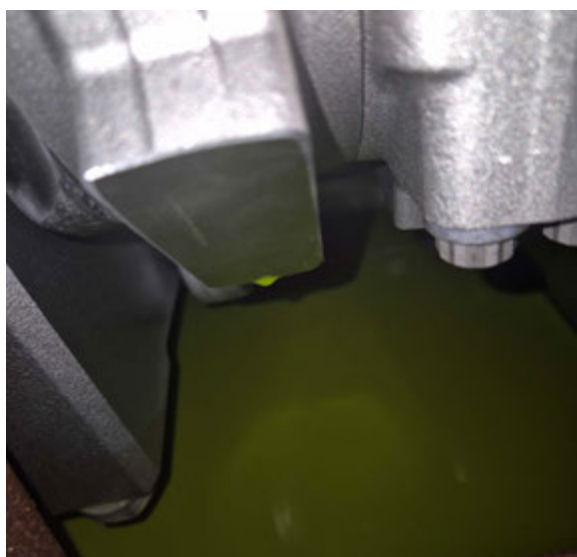
**Turbo:** Both air side and exhaust side inspected and photographed, found to be in as new condition. No ingress of foreign matters.

**Cylinders:** Removed rocker covers, coils/HT leads and spark plugs. Inspected cylinders with borescope, found to be in as new condition. No ingress of foreign matter.

Cylinders 2 & 11 had no coil fitted, cylinder 9 had neither coil or spark plug fitted.

Crankcase doors removed to inspect crank and connecting rods, all found to be in as new condition. No ingress of foreign matter.

The air filter was not fitted but the air inlet chamber was sealed to the elements as was the turbo exhaust.

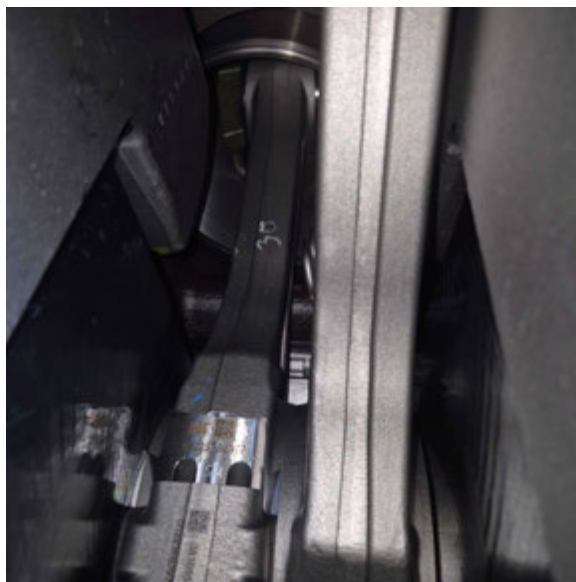
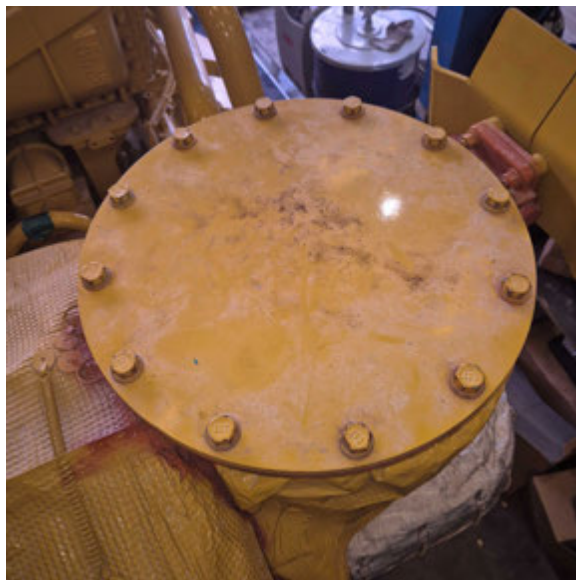
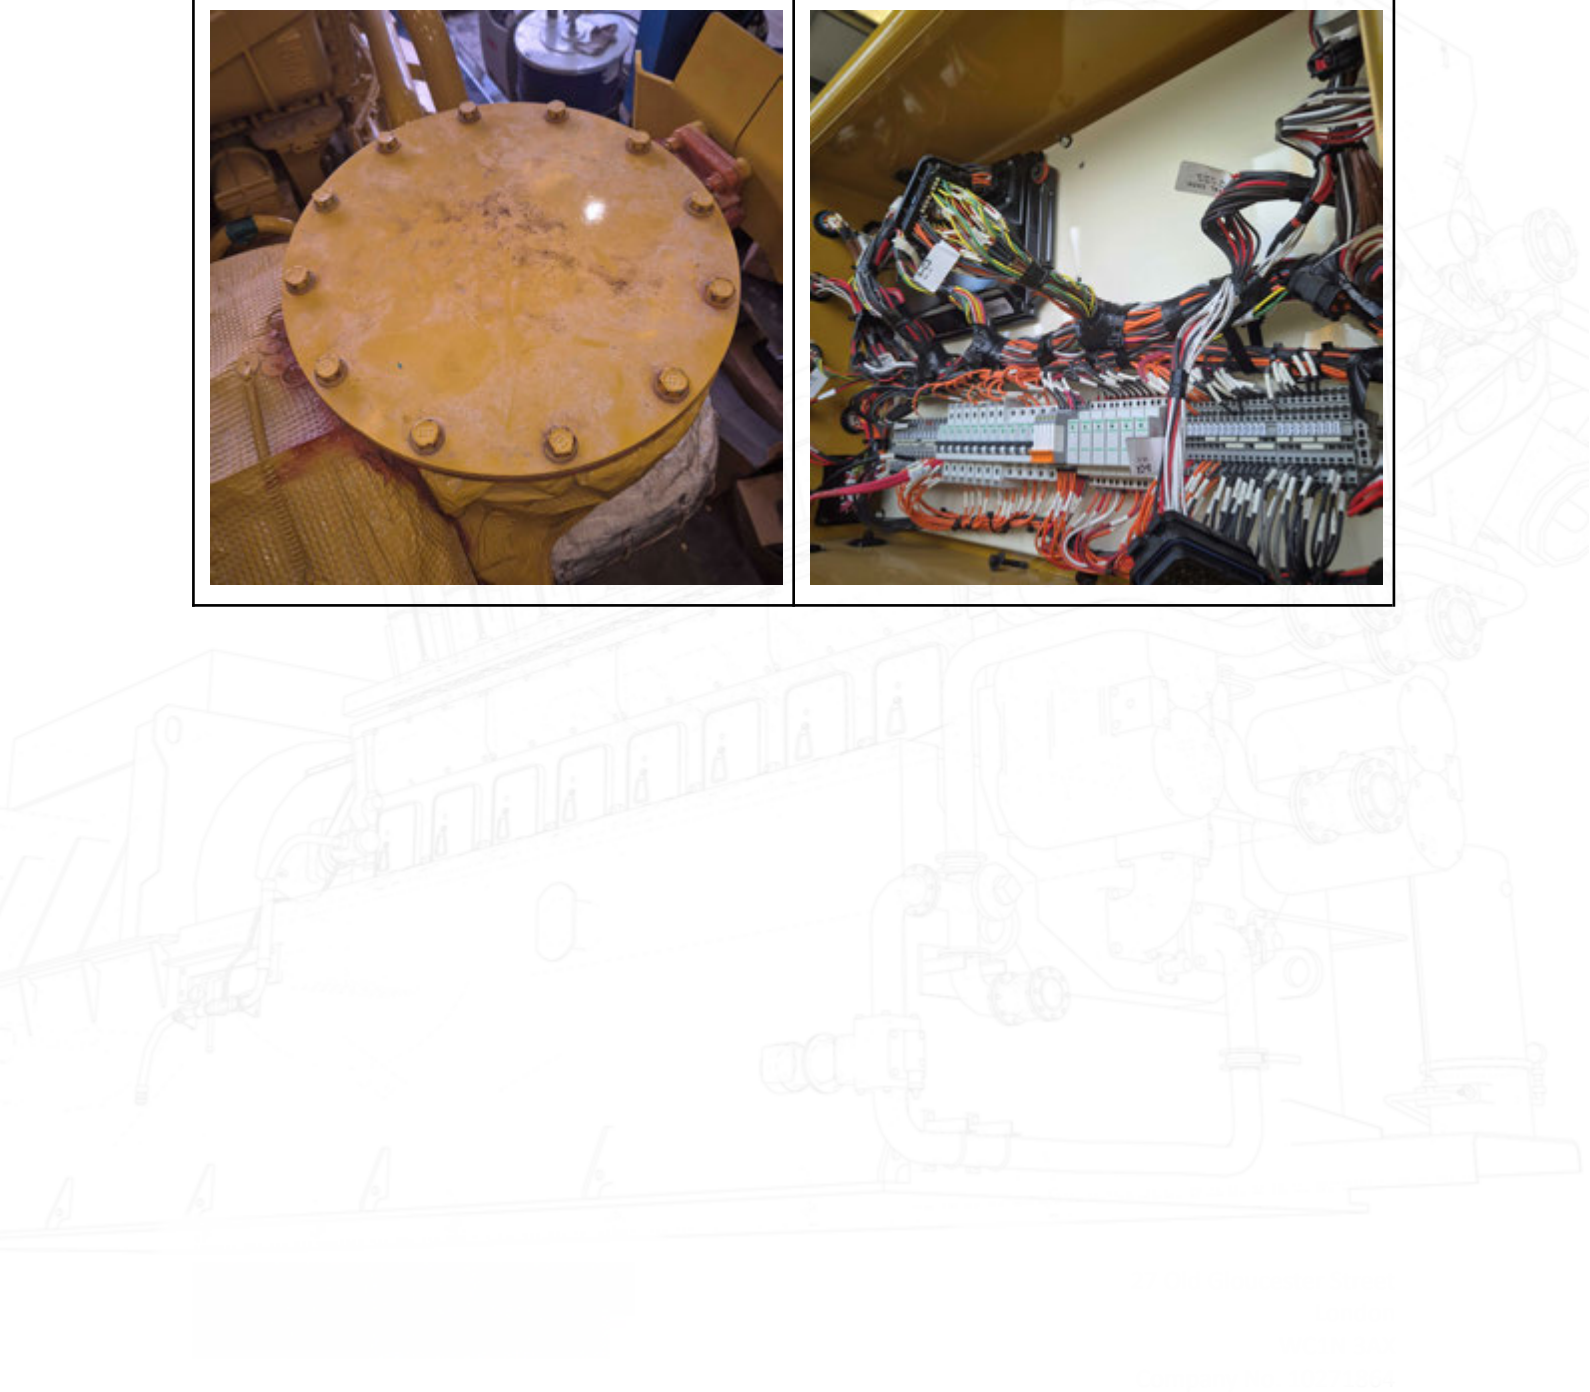
**Turbo:** Both air side and exhaust side inspected and photographed, found to be in as new condition. No ingress of foreign matters.

**Cylinders:** Removed rocker covers, coils/HT leads and spark plugs. Inspected cylinders with borescope, found to be in as new condition. No ingress of foreign matter.

Cylinders 2, 6 & 13 had new coils but used spark plugs. All remaining cylinders had used coils and used spark plugs.

Crankcase door removed to inspect crank and connecting rods, all found to be in as new condition. No ingress of foreign matter. The air filter was not fitted but the air inlet chamber was sealed to the elements as was the turbo exhaust.

Cylinder 16, T/C missing.
